3 Existing Conditions Evaluation

Building Conditions Analysis – Gymnasium (Revised final report for Existing Gymnasium June 8, 2011)

Final Existing Structural Conditions Report

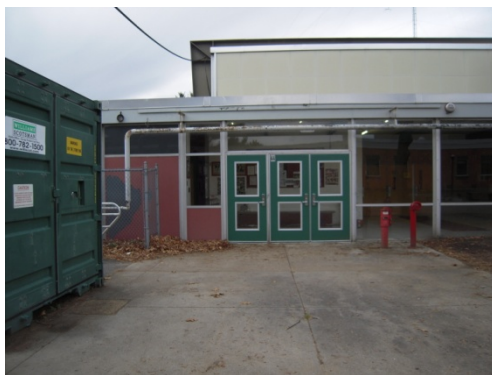
The performance gym has the existing curtain wall system with single pane glass and metal panels. The Building envelope is poorly insulated with a weak air barrier. The paint finish on the metal panels is peeling in many locations on the east wall. Fiberglass doors were installed at the east entry. The structure of the gym is exposed on the outside of the building causing thermal bridging, the exposed steel is beginning to rust and deteriorate in many locations. The roof is PVC and needs to be replaced.

Exterior entry to performance gym

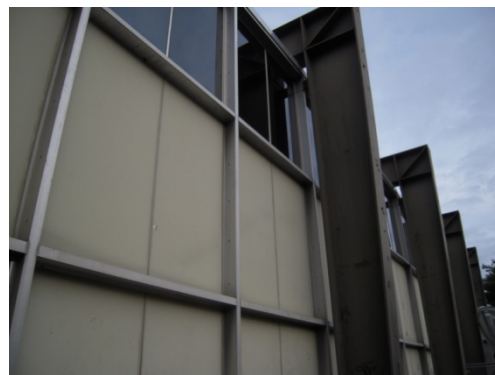
Exposed performance gym structure & curtain wall

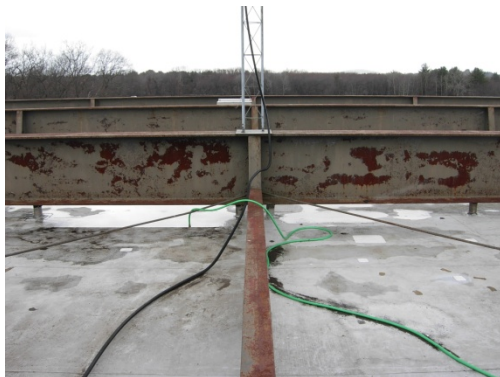
Deteriorating steel structure

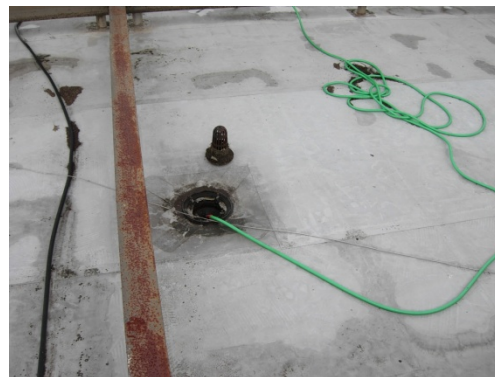
Failing roof drains and thermal bridging of exposed structural steel

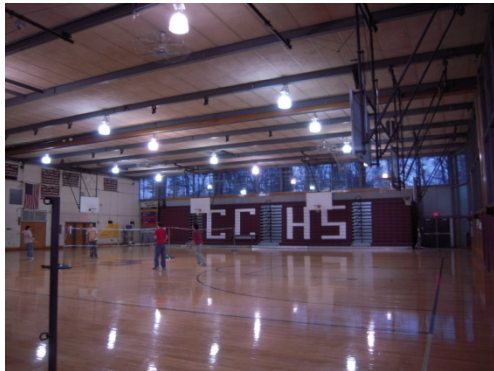
The ceiling height in the upper gymnasium is approximately 20'-8 1/2" clear from the finish floor to the underside of the deck. A regulation size high school basketball court requires 25'-0" clear ceiling height and a regulation size high school volleyball court requires 23'-0" of clear ceiling height. The existing steel structure would need to be raised and/or reframed in order to provide the proper clearance in this space for a performance gymnasium.

Performance gym

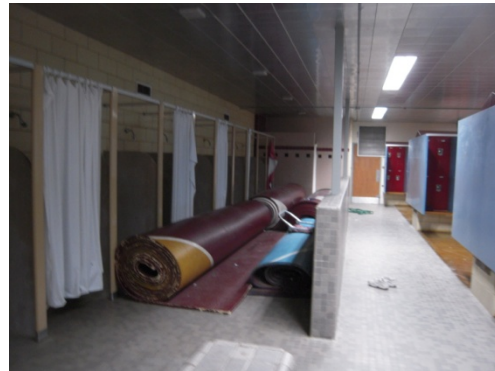
Girls locker room showers

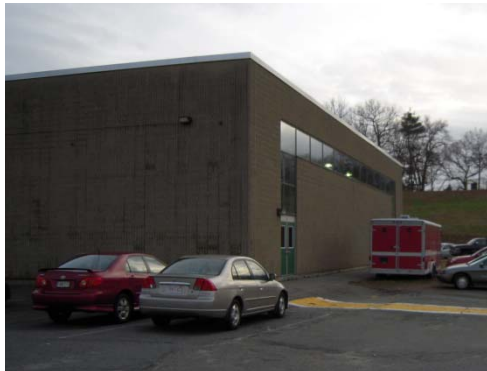
The building envelope for the lower gym is the existing 1970's split faced ribbed block. The building envelope system is poorly insulated and does not provide an air tight barrier. The window units are an aluminum storefront system with single pain glass. Fiberglass doors were installed at the east entry. The building has anodized aluminum fascias. The EPDM roof is in poor condition.

North and west wall at lower gym

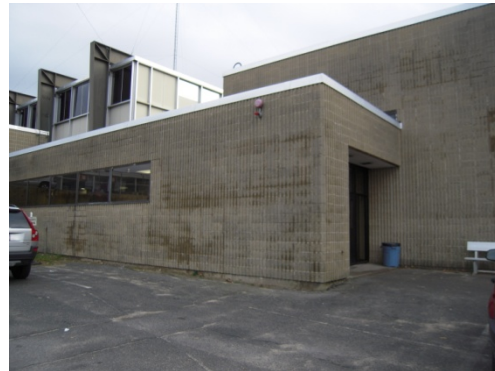
Lower gym entry and ramp to performance gym

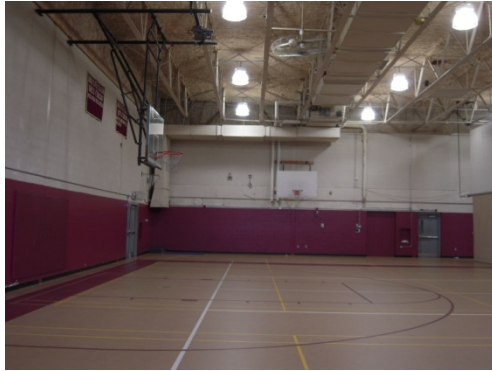
The lower gym has a worn and faded rubber floor, painted CMU walls, an applied acoustical ceiling with exposed steel trusses and pendant lights. There is a roll up curtain divider that appears to be functioning and batting cage nets that are hung from the roof structure.

Rubber floor in lower gym

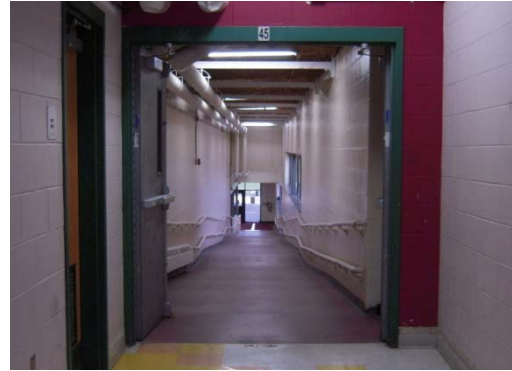
Ramp down to lower gym

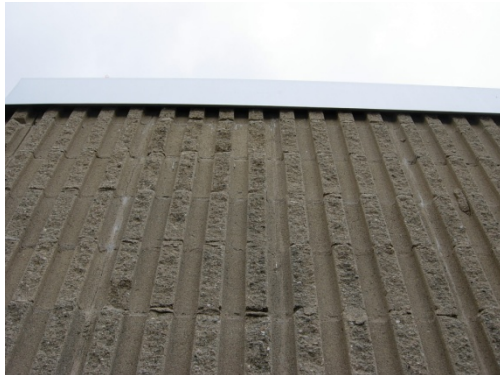
Storms during this past winter have uplifted the EPDM membrane off of the roof deck. It is believed that the heavy winds entered under the flashing at the openings in the fluted block and lifted the roof membrane. The school has mechanically fastened the membrane back down, but the wind is still able to get under the flashing

Strong winds have entered between fluted block and flashing and lifted the EPDM off of the roof

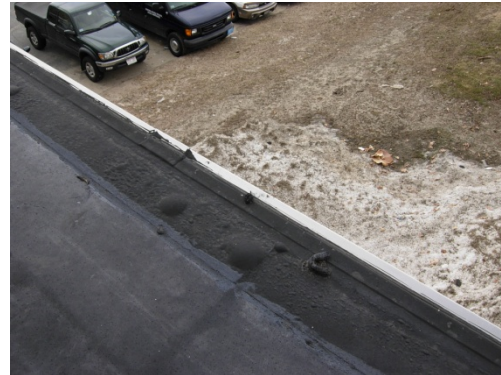
EPDM blistering and failing roofing adhesives.
