**PHASE I PRELIMINARY SITE ASSESSMENT
RELATIVE TO
OIL AND HAZARDOUS MATERIALS**

**Concord Carlisle High School
500 Walden Street
Concord, MA**

May 2011

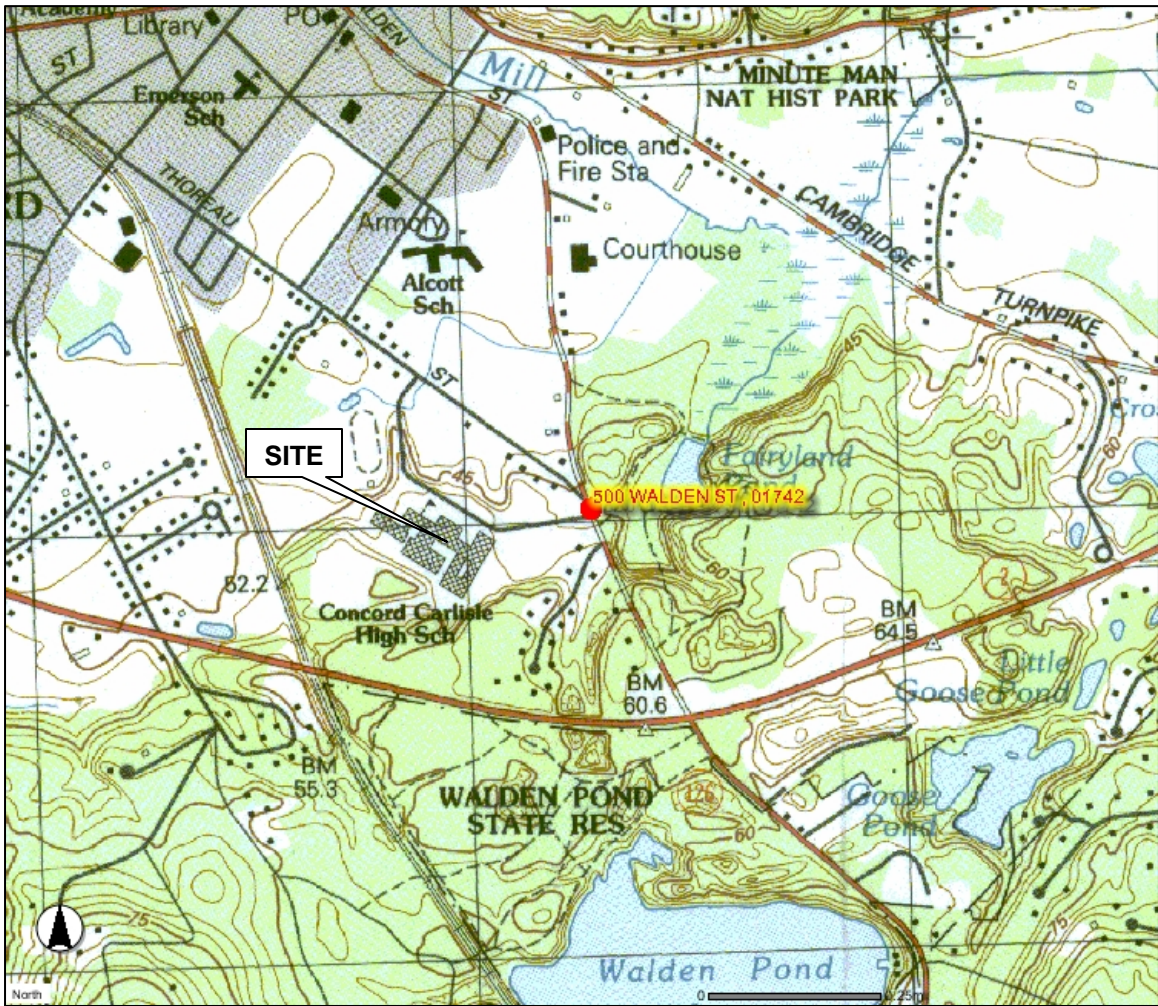
FIGURE 1

The subject Site is located at 500 Walden Street, Concord, Massachusetts and consists of the Concord-Carlisle High School. Additional facilities, the Beede Swim and Fitness Center and school bus transportation facility, are also within the campus but are outside of the scope of this assessment. The campus is comprised of a parcel of land that totals approximately 94 acres and is located on the Town of Concord Assessor’s Map 11H, Block 298. The campus is located on the United States Geological Survey (USGS) Concord, MA (1987) Quadrangle Map (Refer to Figure 1 in Appendix A for the Locus Map) at approximate UTM coordinates 307325.4 mN, 4702042.0 mE and latitude 42° 26’ 55.3’’ N, longitude 71° 20’ 34.4’’ W. Figure 2 in Appendix A is an Assessor’s map showing the property limits.

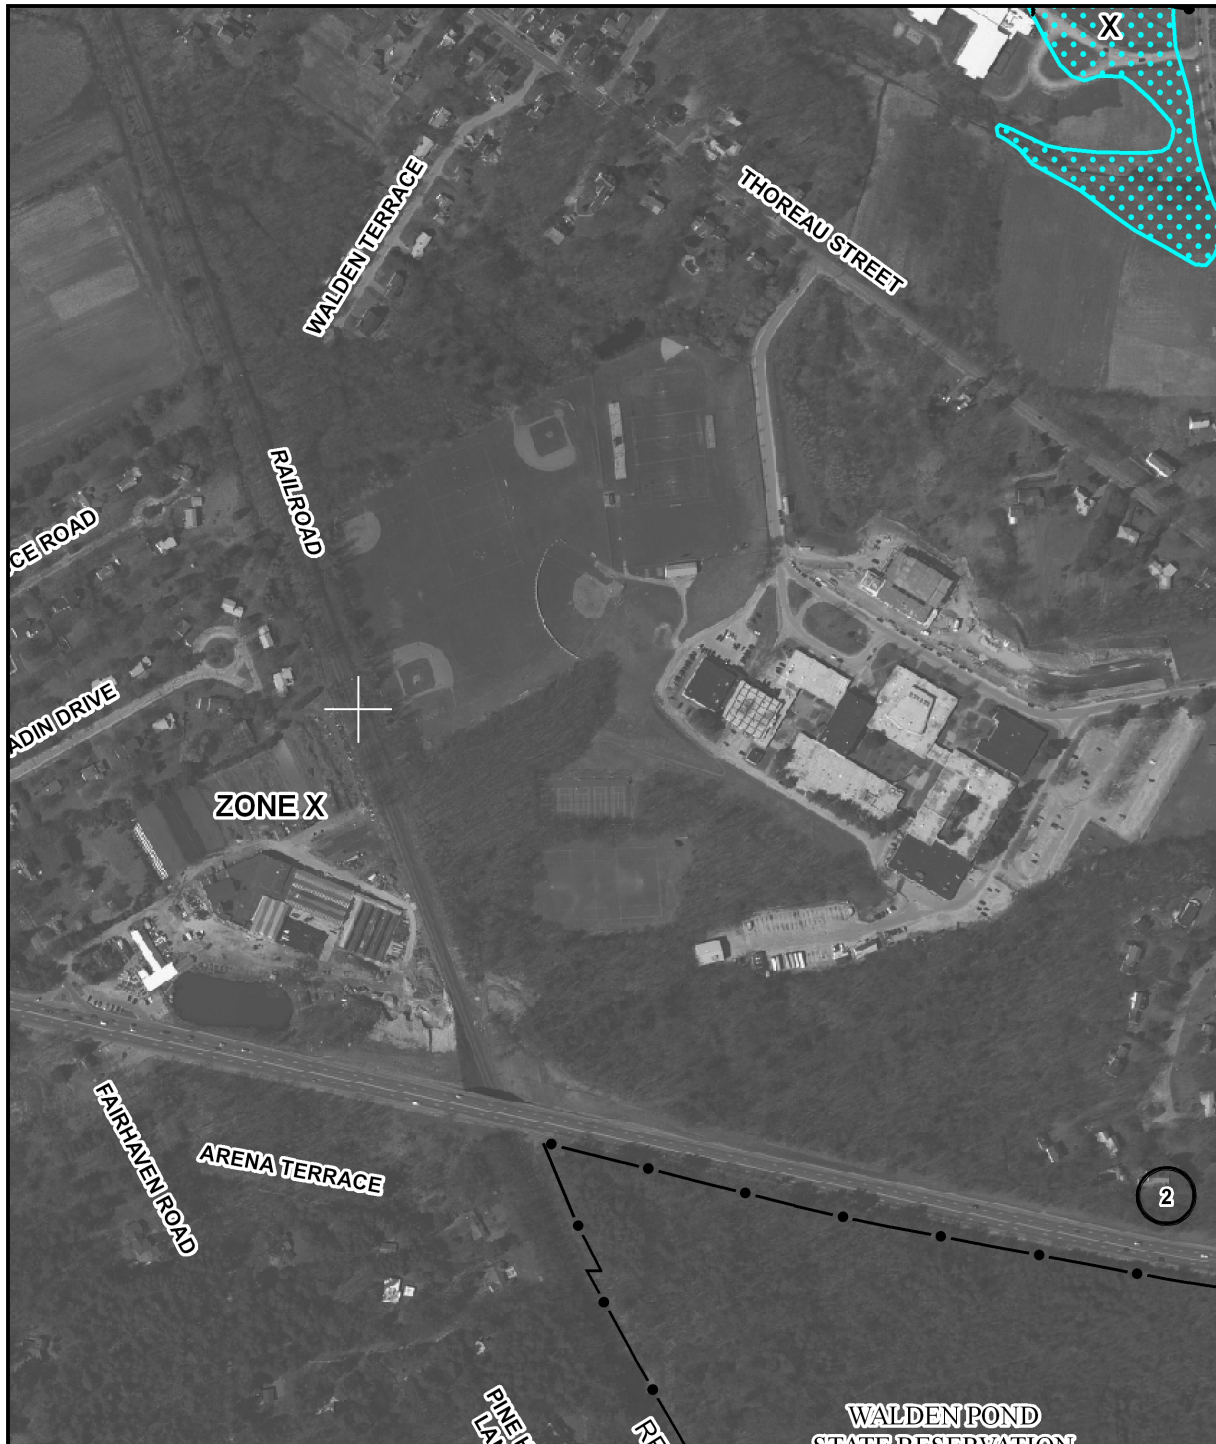
Figure 7

According to the Federal Emergency Management Agency (FEMA) Flood Insurance Rate Map (Panel 25017C0378E), the Site is located within a Zone X, which is classified as an area outside of the 0.2% annual chance floodplain (Figure 7 Appendix A).

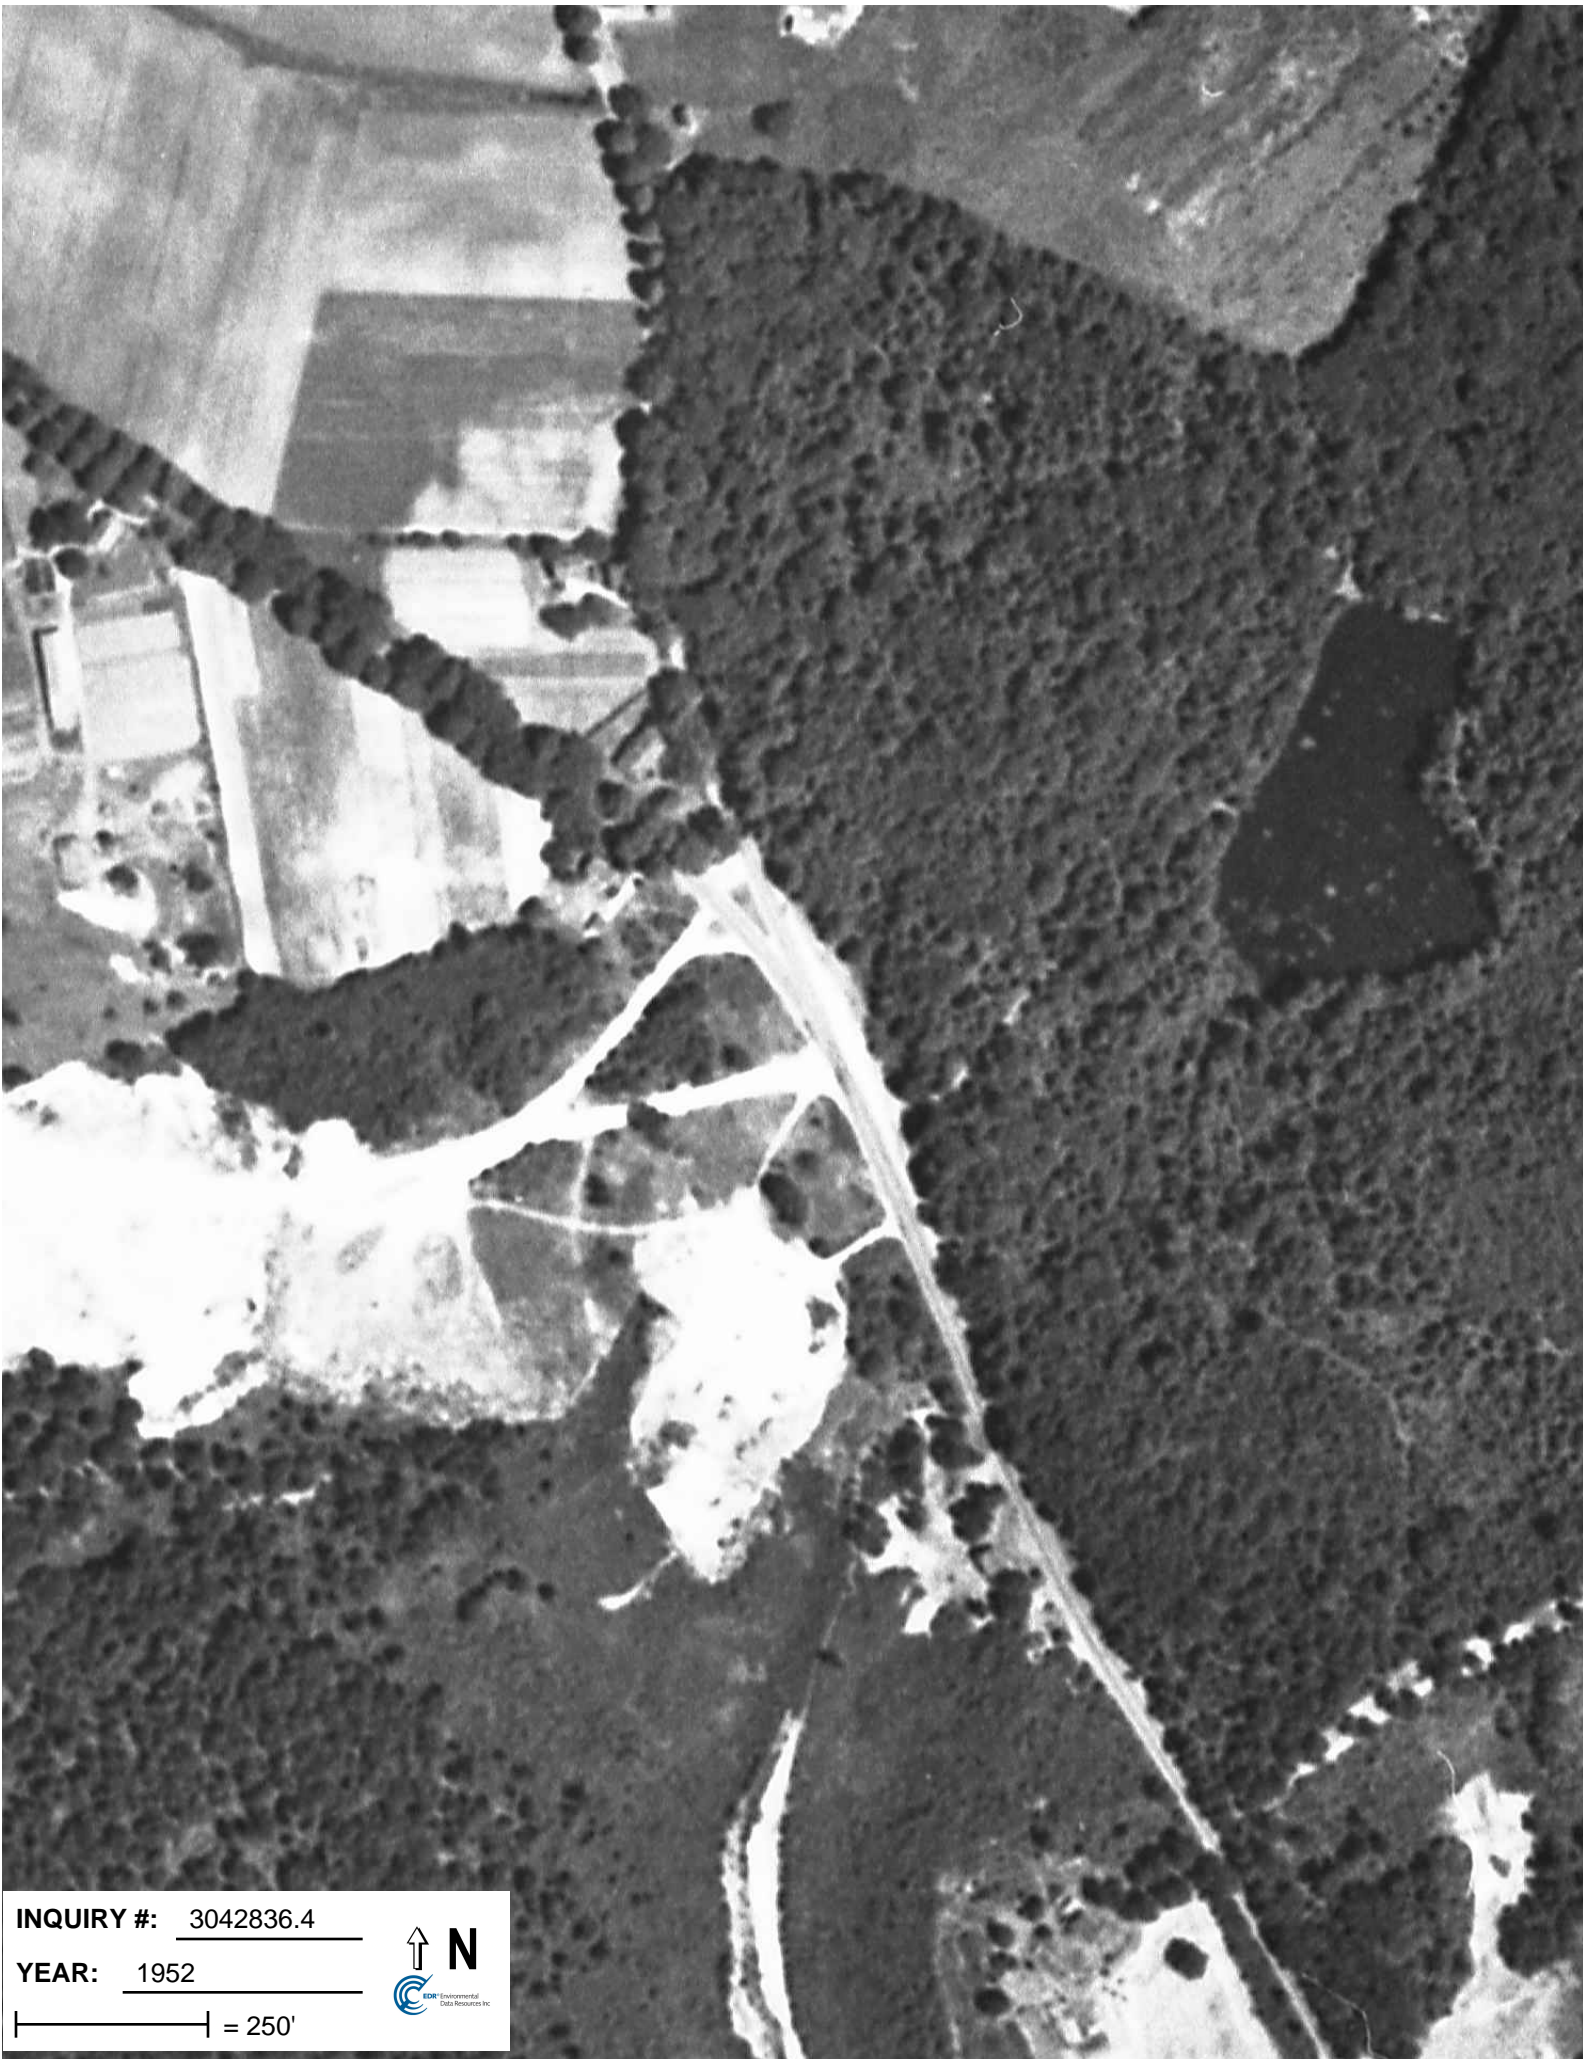
YEAR: 1952

CDW reviewed aerial photographs of the Site and surrounding area dated 1938, 1952, 1960, 1969, 1978, 1980, 1985, 1995 and 2006. The 1938 aerial photograph of the Site shows an access road leading to disturbed areas. To the north of the Site is agricultural land and to the west wooded areas to the south and east. The 1952 aerial photograph of the Site shows that area of disturbance increased. The 1960 aerial photograph shows the newly constructed high school building and athletic fields. From the 1960s through to 2006, the aerial photographs show single family homes constructed on the once agricultural land to the north and west of the Site. The wooded areas to the south and east continued to remain undeveloped and are now protected open space. The 1952, 1969, 1980 and 2006 aerials are provided in Appendix B.
